Tour Report for visit to construction site under Shingkar, Bardo and Nangkor Gewogs

Tour Date: 16-19/09/2021

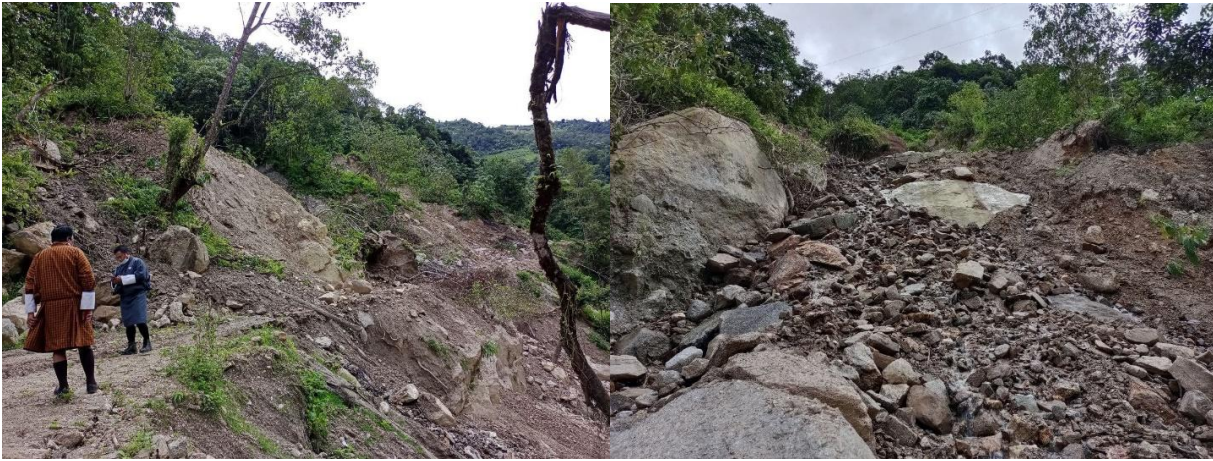
1. About 100m before the bridge site, huge landslides had occurred damaging the road. Besides, the area has continuous water flow from above.
2. The actual construction site is intact and the area for abutment has not been affected by the landslide.

3. The proposed bridge site is rocky and stable, suitable for the construction of bridge abutment.
4. The stream flowing by, irrigation water from the paddy field and school stormwater above is the main cause of the erosion and landslide.

5. It is observed that the landslide has been triggered due to improper drainage from above and is basically on the surface, which does not have a significant effect on the bridge abutment construction.

Flooded and landslide area at Zamdong

1. The team recommended and decided to carry out the bridge construction in the already identified location;
2. The team recommended carrying out mitigation measures like diverting the stream, irrigation water and school stormwater from above to a different location;
3. The team also advised the Gewog engineer to be at the site for a week and further access the situation while clearing the sliding area and constructing the foundation.

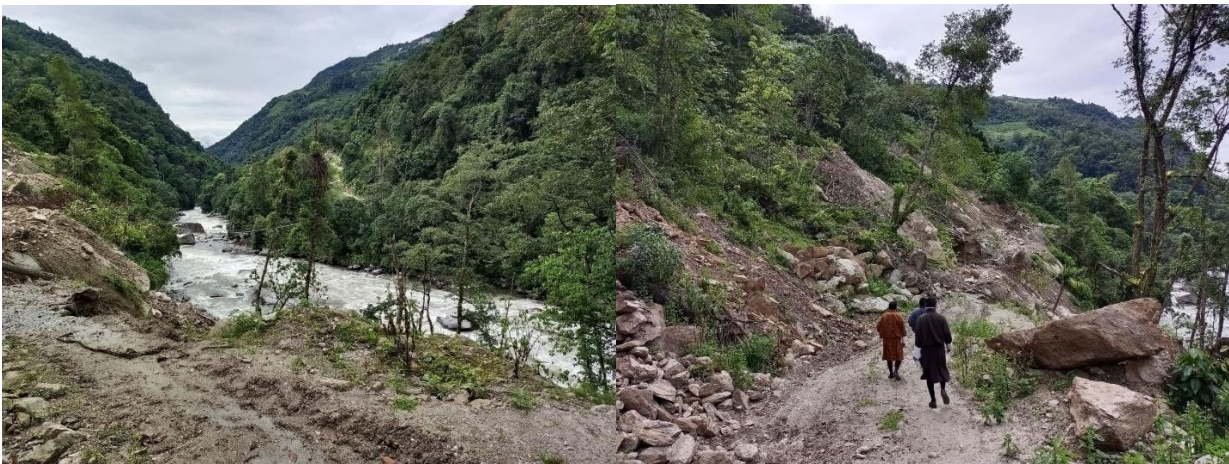
The actual location of the Zamdong bailey bridge construction site

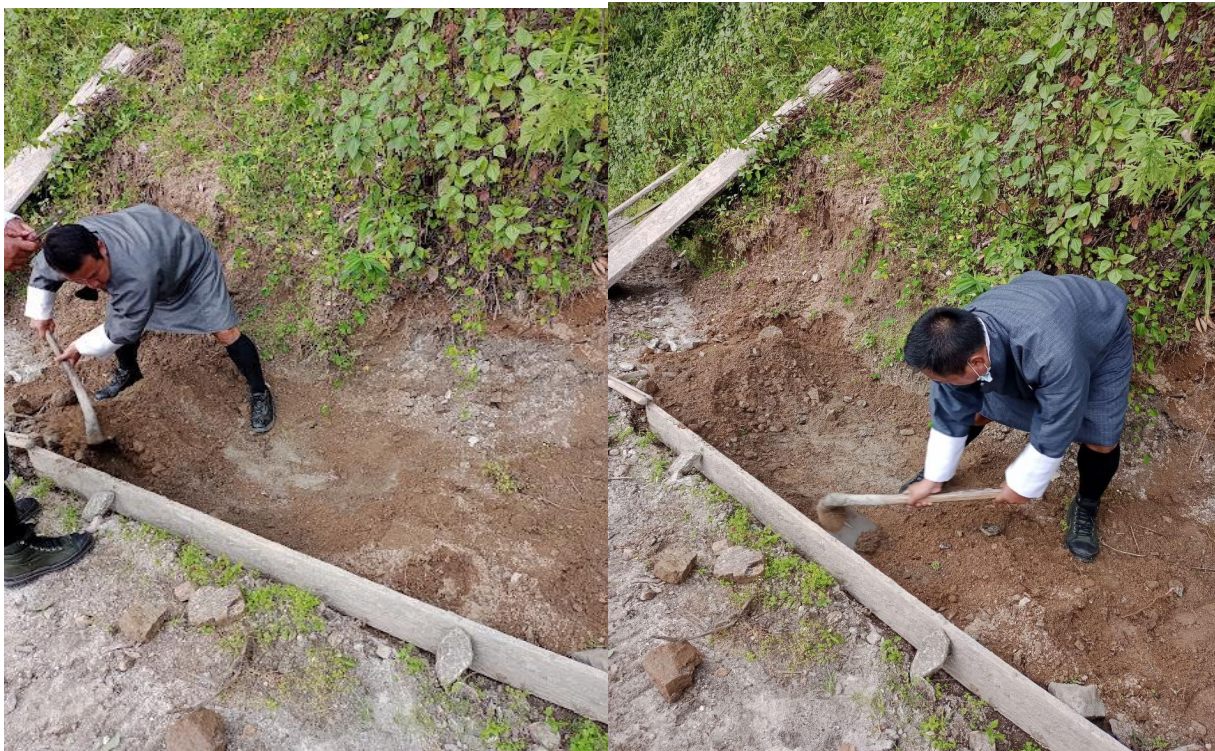
3. It was observed that the PCC thickness for the drain work, width-wise, was not maintained uniformly
4. The instructed the Contractor's site Engineer and the labour to maintain uniform thickness throughout as per the standard and maintain quality work. 4. Always maintain the right ratio of cement, sand, aggregate and water;

Site engineer showing an example as to how the foundation of the drain should be laid

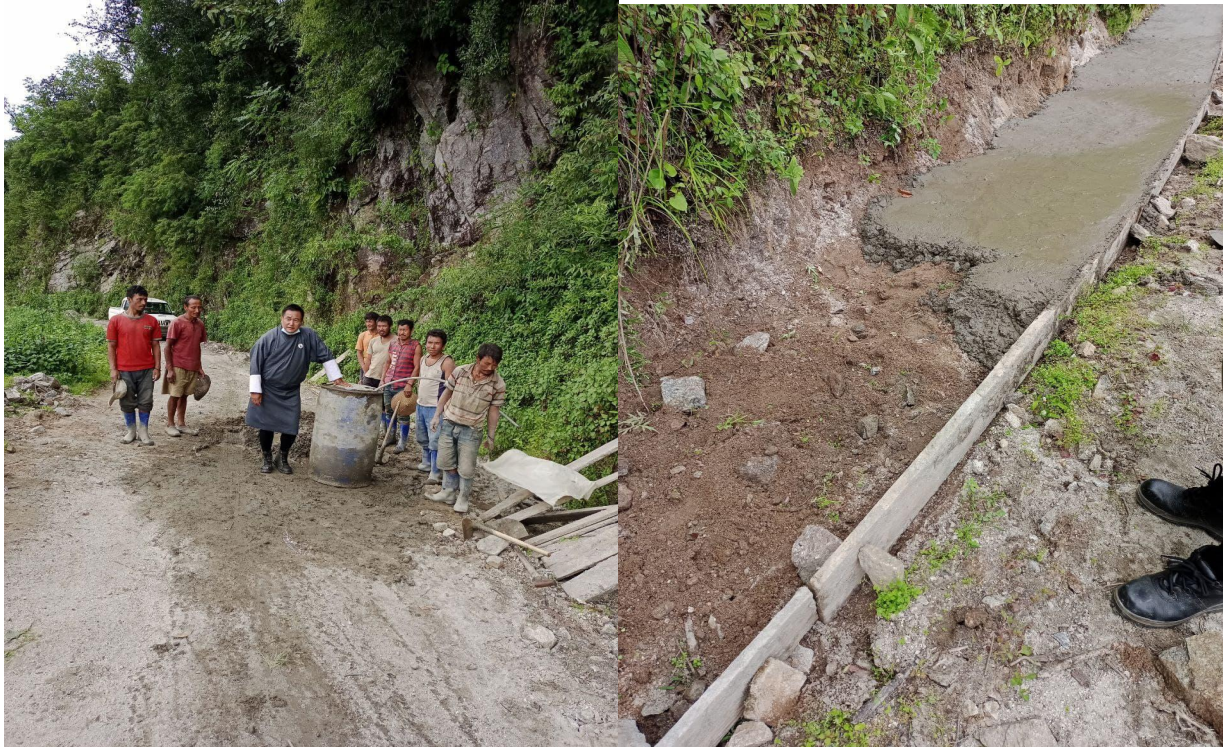
With Labourers at the ongoing construction of drains at Bardo GC road blacktopping

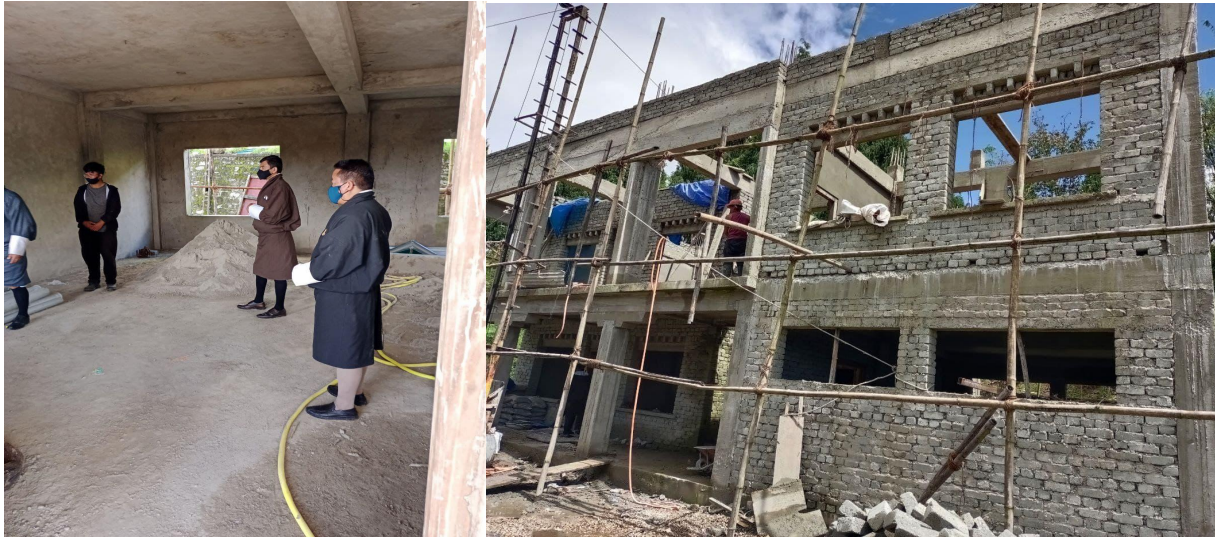
Progress of 32 bedded hostel construction at Buli CS

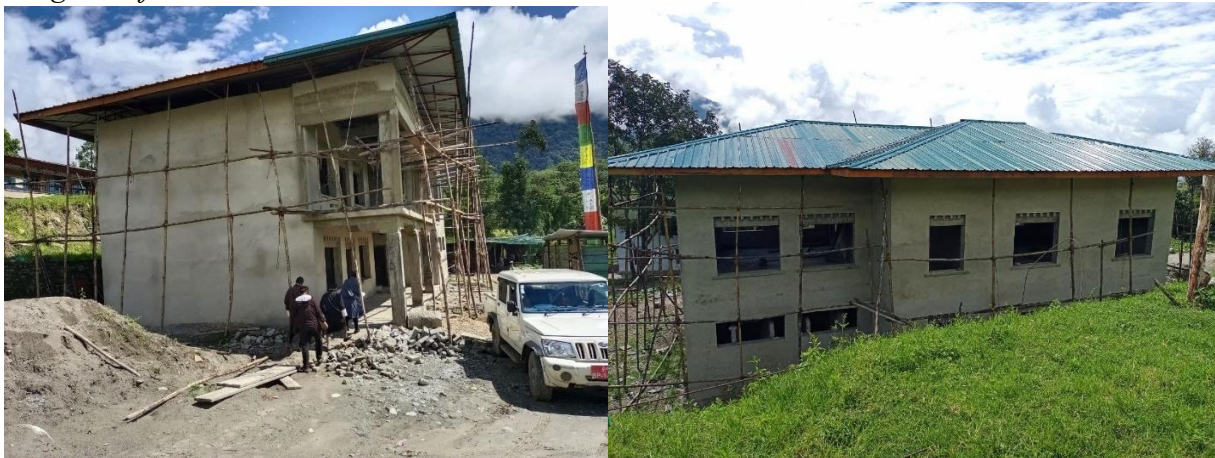
Progress of 32 bedded hostel construction at Buli CS

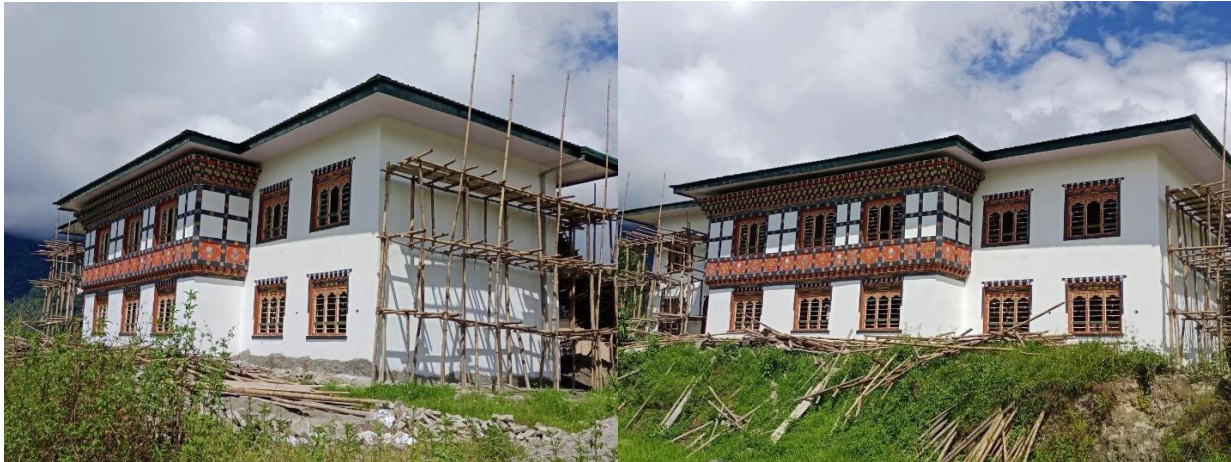
Progress for the construction of 6 unit classroom at Buli CS

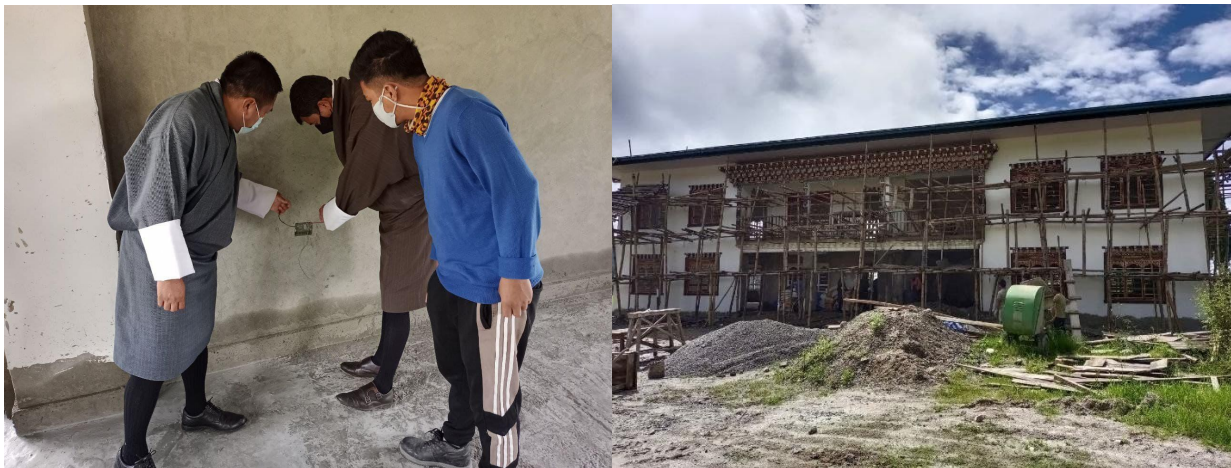
Quality check for electrical wires

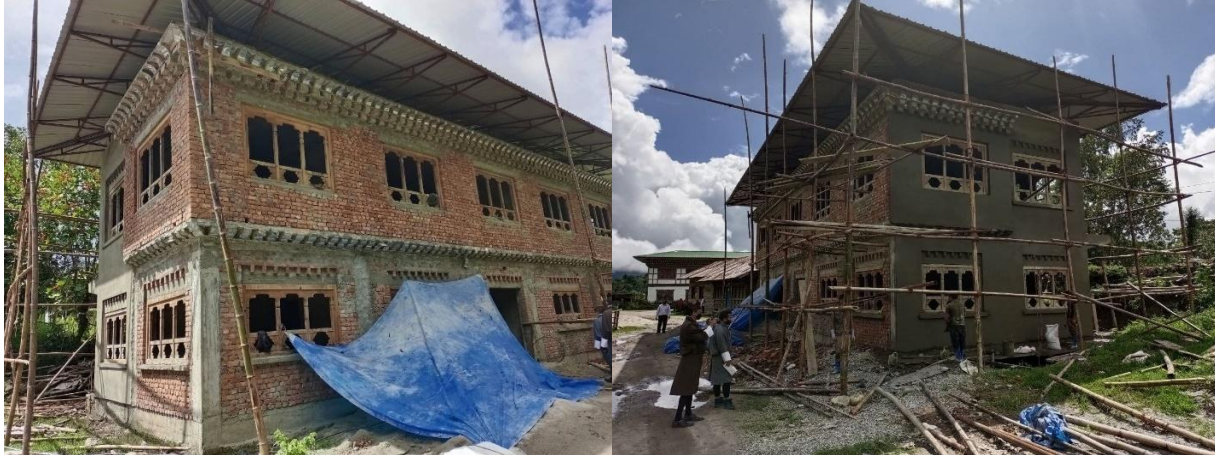
Progress of Buli BHU staff quarter construction

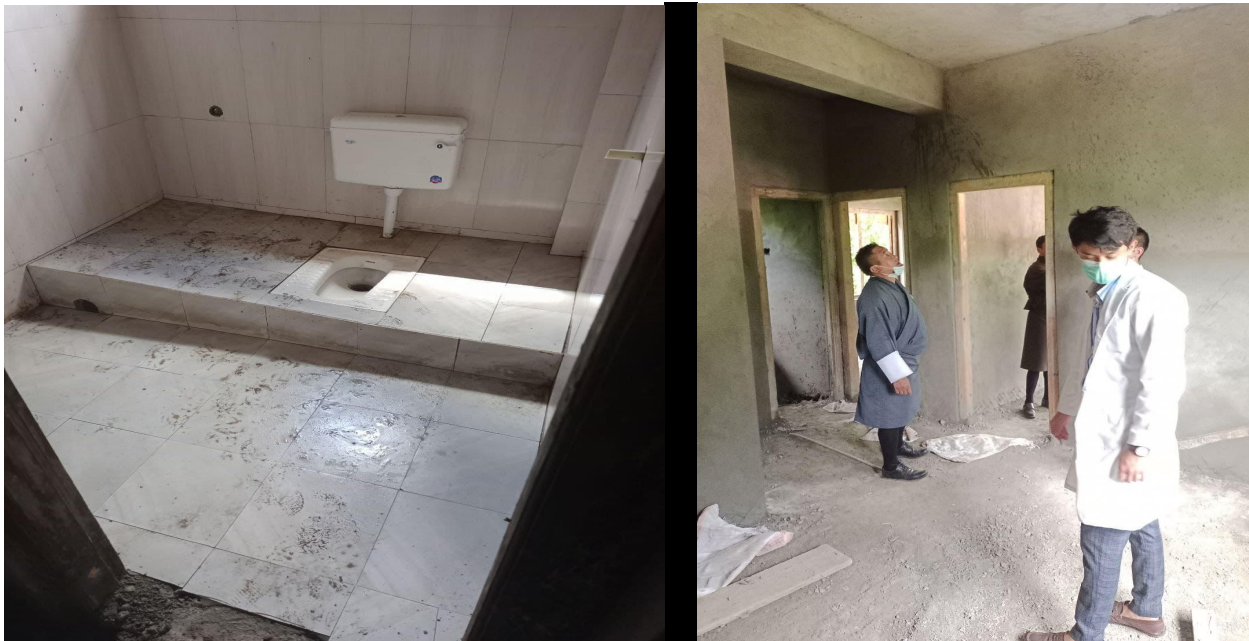
1. Overall progress is good
2. Plastering work looks good
3. Tiles work looks good

Tiles work finishing at Buli BHU staff quarter construction

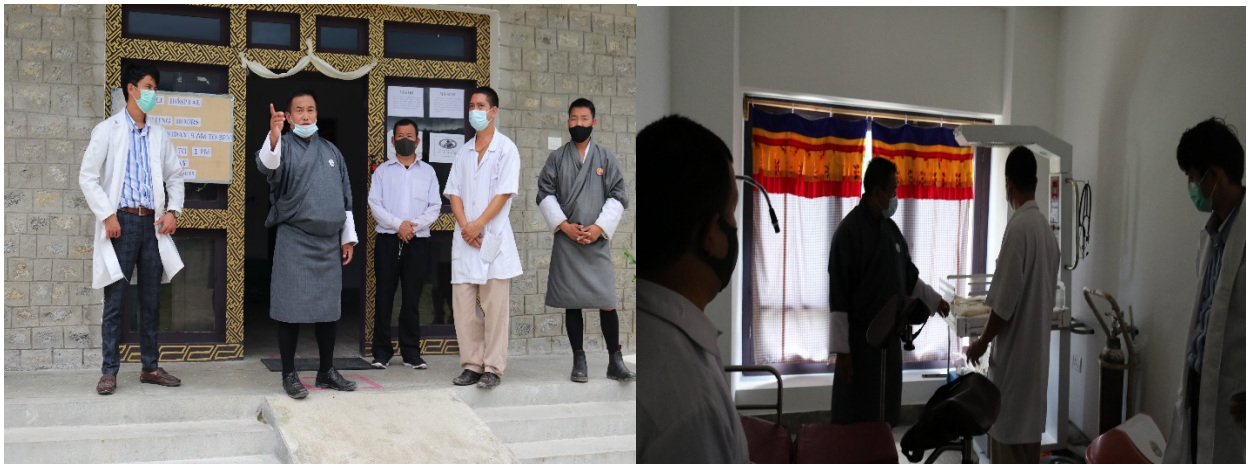
Visit to delivery room

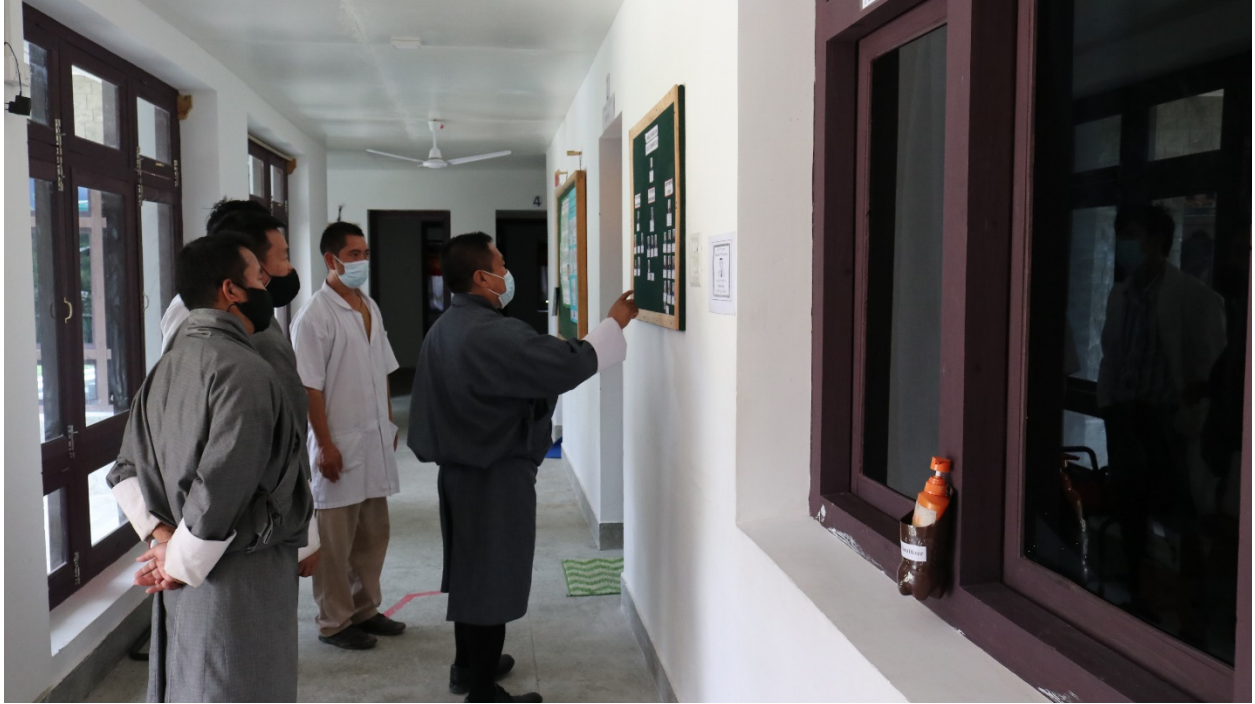
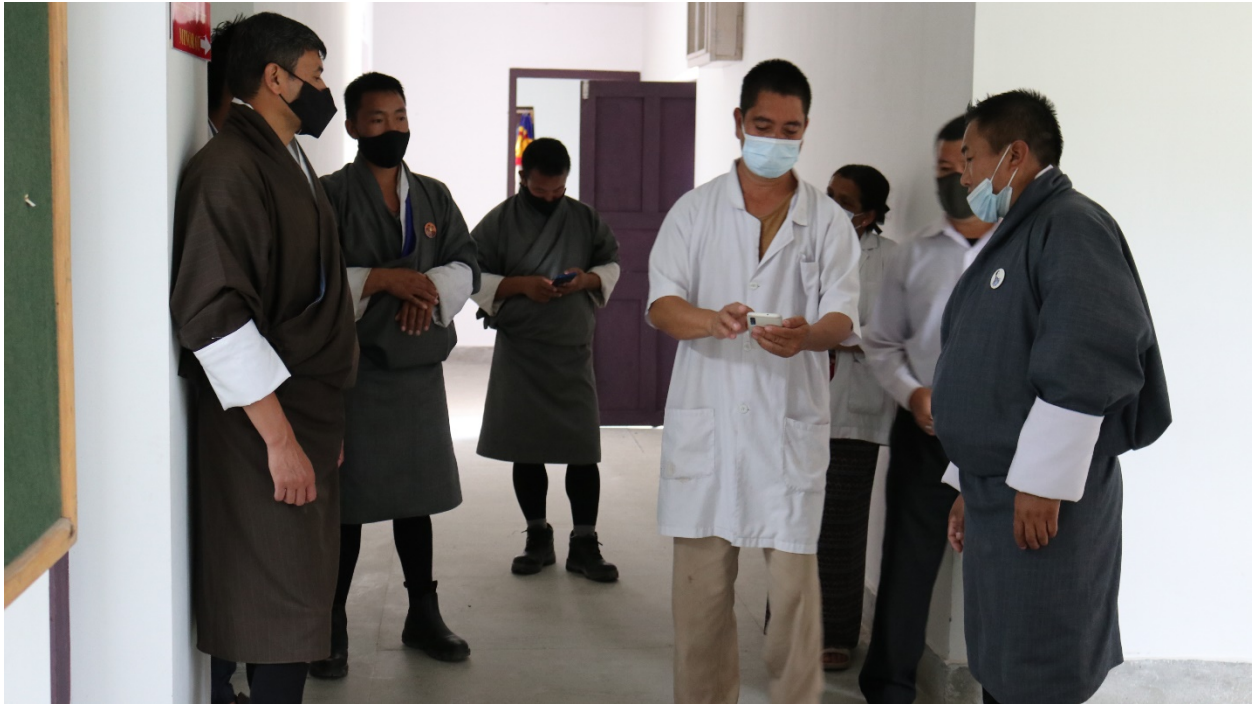
Visit to newly constructed Buli Hospital
